Water-Wand Cartridge Cleaner - Technical Bulletin

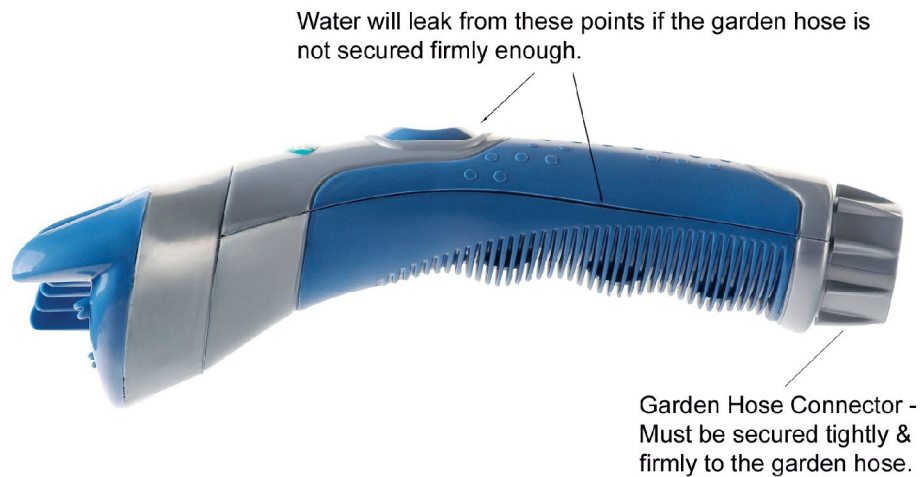
The outer housing of the Water-Wand does not carry any water flow or water pressure. It is therefore highly unlikely that a leak in the product itself will develop here. The water is carried through a tube that runs up the inside of the housing. If the garden hose is not firmly secured to the product's garden hose connector, water will leak into the housing and out of the various seems and openings. This problem is simply resolved by tightening up the garden hose connection.

Water-Wand
pool and spa cartridge filter cleaner

Many garden hoses and their associated fittings vary in style. If you are having difficulty as a result of this, the use of an additional hose washer may help provide a perfect seal.
